#### Polarimeter status

M. Dugger, January 2014

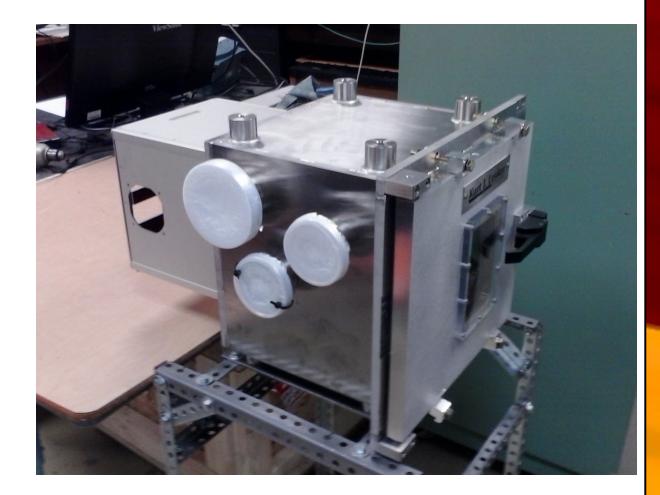
Chamber with preamp enclosure attached (temporarily)

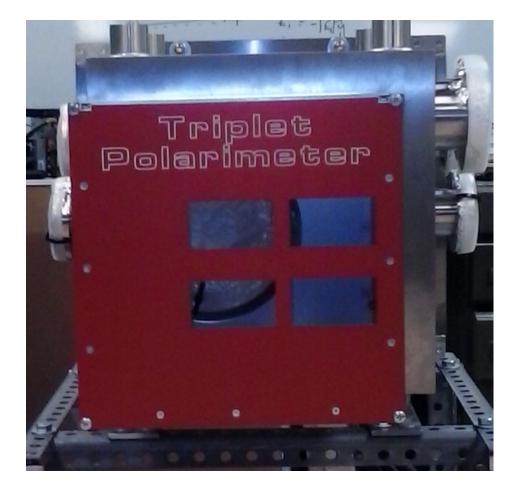
Back view with preamp enclosure attached

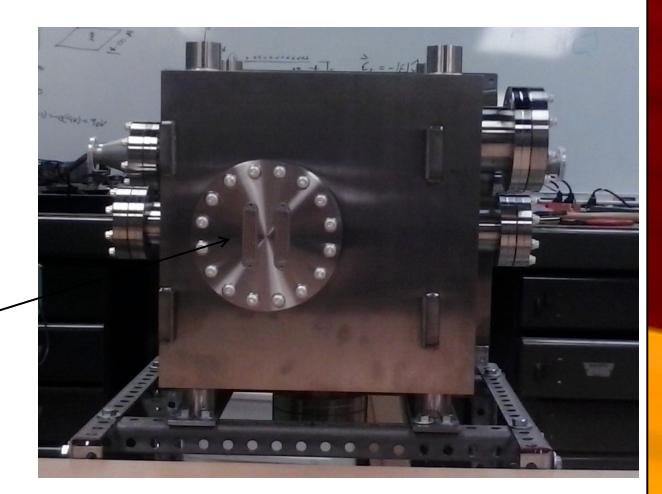
- Back view without preamp enclosure
- Detector signals come out of this flange

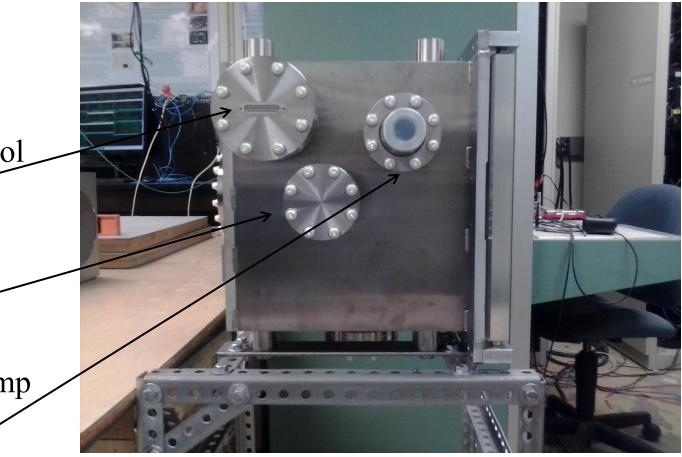
- Side view without preamp enclosure
- Motor control flange
- Beam-line flange
- Vacuum pump flange (for testing)

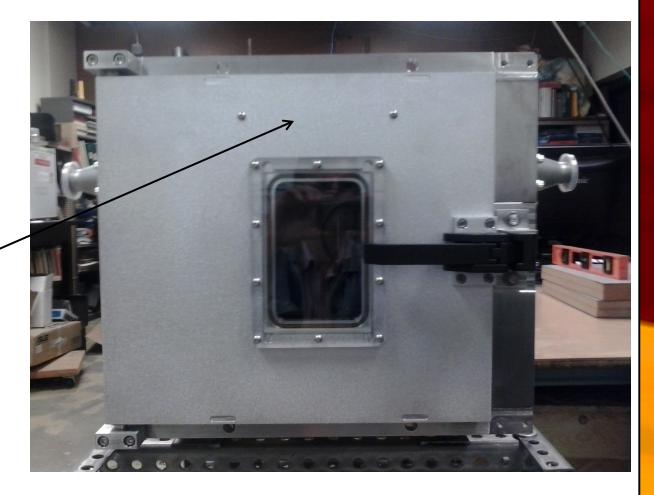
• Front view

• Removed Lesker identification plate from here

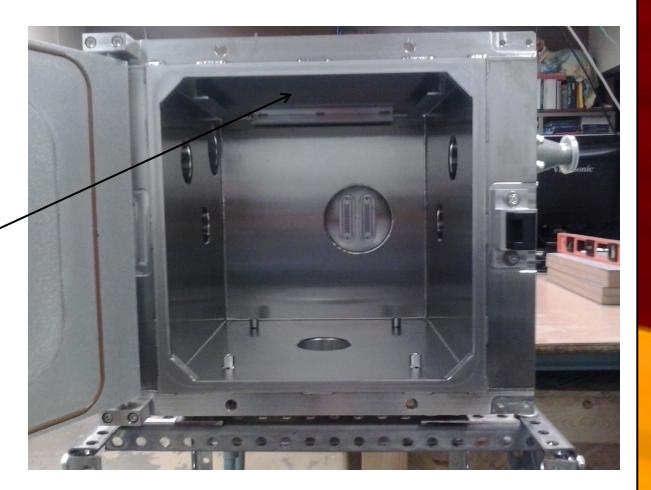
- Front view with door open
- Removable plate goes here -
